# 406 MHz EPIRB False Alerts Study

# EPIRB False Alerts Study

Study was research project by:

- Larry Yarbrough, CAPT, USCG (Ret)  
USCG District 7 (dpi)
- Newton Anderson,  
USCG Auxiliary
- Greg Johnson  
USCG Sector Charleston

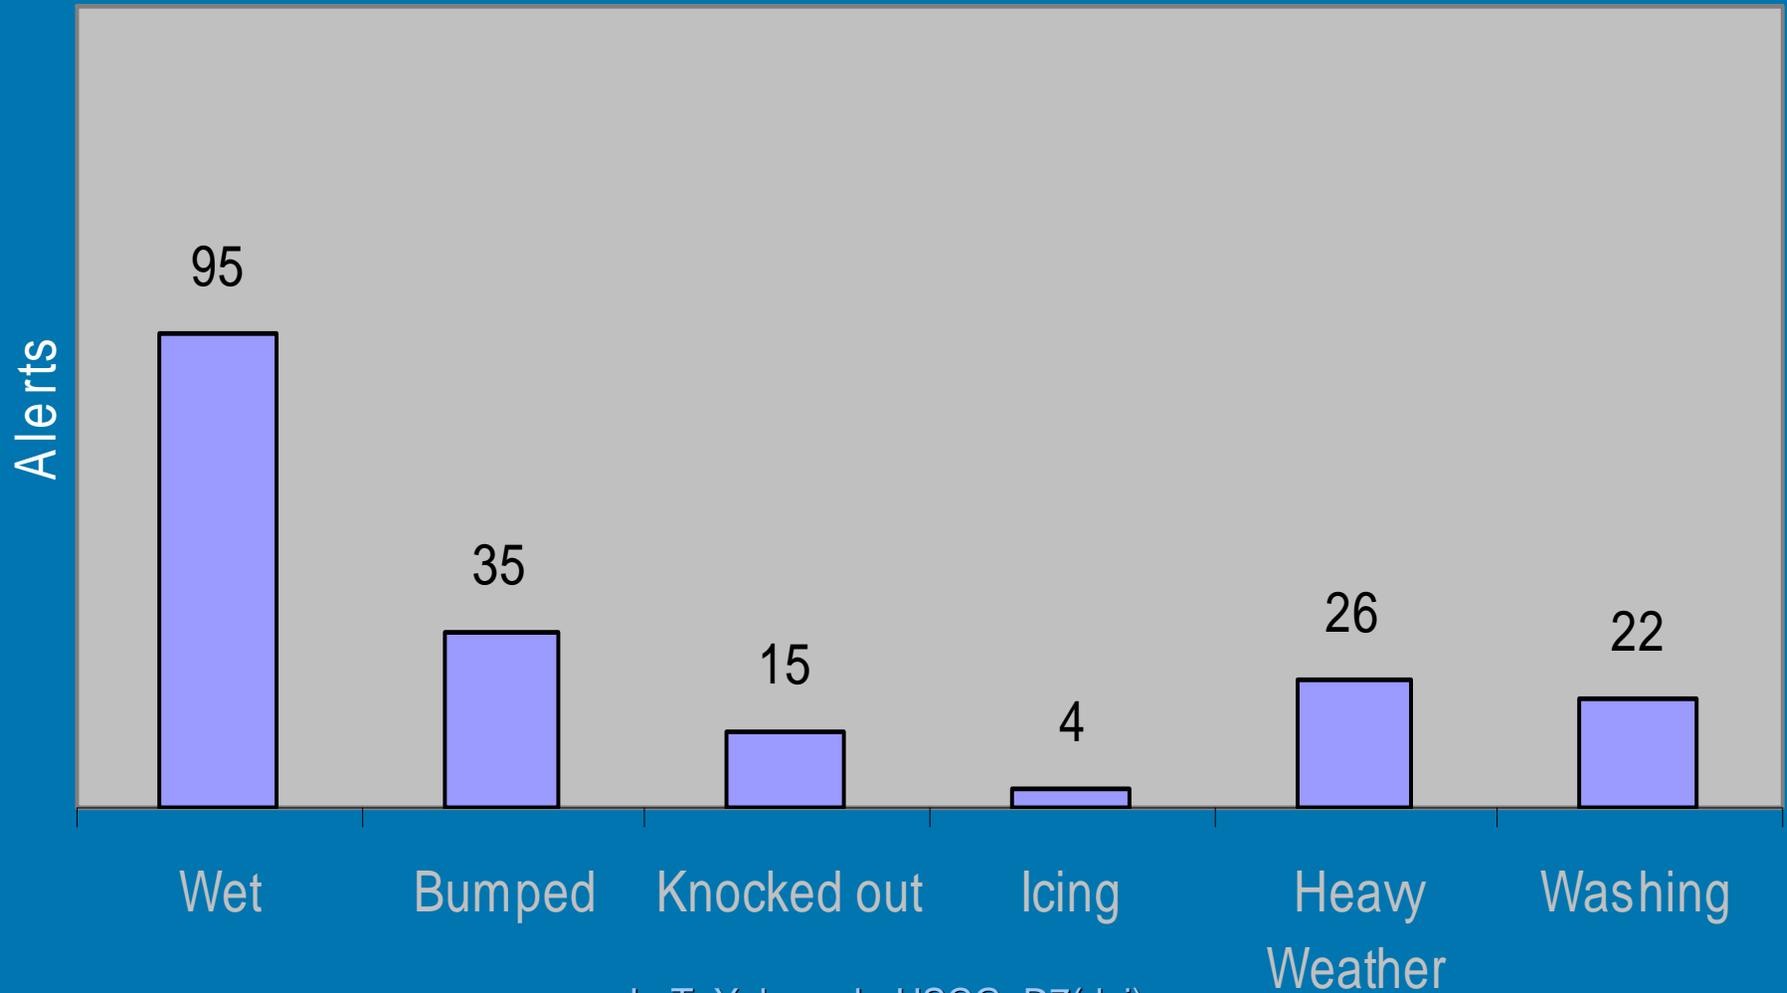
# False Alert and EPIRB in Bracket

69% (161) Caused by Failure of “The bracket decoupling function” to control the EPIRB

69% (161) Activated when bracket should have prevented activation

Failure of “The bracket decoupling function” to control the EPIRB

Require or at least encourage the bracket to be included in an EPIRB service
